Duct Cutting: MULETAPE® vs. Rope

Burn Through: The Case for MULETAPE vs. Rope

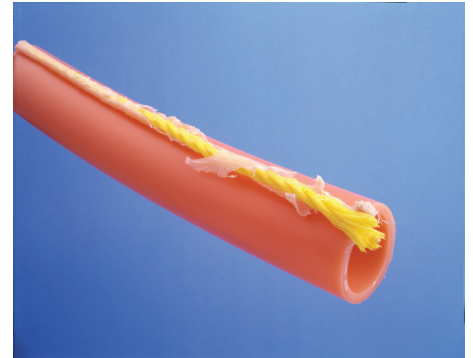
NEPTCO Duct Cut Tester

A: NEPTCO has gone to great lengths to test this theory by duplicating installation conditions in the lab and in the field. Our research engineers designed the Duct Cut Tester to evaluate the performance of various conduit materials and winch lines under typical installation conditions.
